COMBINATION OF THREE METHODS OF PHOTOVOLTAIC PANELS DAMAGE EVALUATION

T. Olšan, M. Libra, V. Poulek, B. Chalupa, J. Sedláček

Czech University of Life Sciences Prague, Faculty of Engineering, Prague, Czech Republic

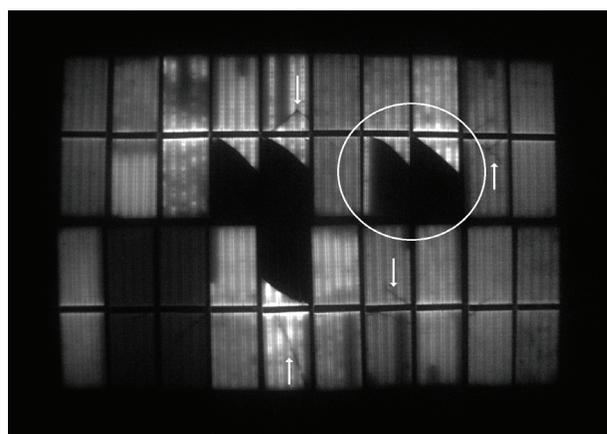
The PV panel EL image is given in Fig. 1. A severe damage is evident. White arrows indicate broken PV cell sections with uninterrupted contact. PV cell sections with interrupted contacts are also well visible. Parts of PV cell sections with no flow of current are black because there is no EL. Even in some undamaged sections we can see that the density of current is not homogeneous. Lighter regions match higher density of current. A detail of the place in the visible spectrum with a little circle is given in Fig. 2. There we can see cracks and interruption of contacts even with the unaided eye and with a magnifying glass. Little cracks without interruption of contacts are usually not visible by this method. For comparison, a larger PV panel without any damage is presented in Fig. 3. There are no apparent cracks, only small defects due

Fig. 1. Image of electroluminescence of a small damaged photovoltaic panel

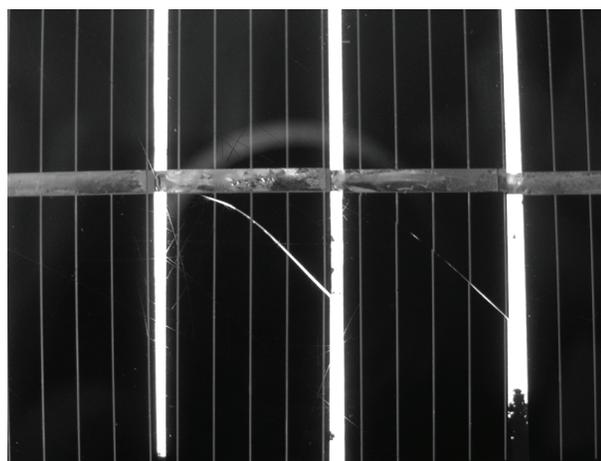
Fig. 2. Detail of the damaged place in the visible spectrum

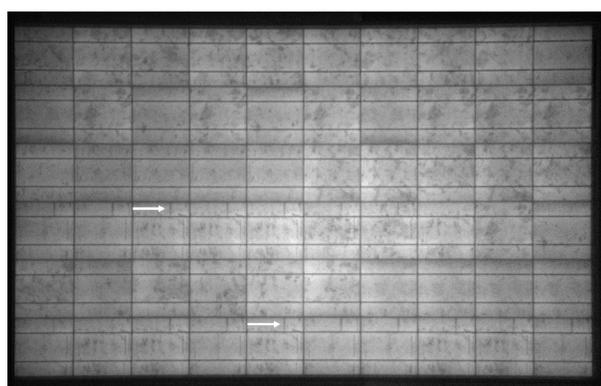
Fig. 3. Image of electroluminescence of a larger undamaged photovoltaic panel

to interruption of the connection lattice caused by screen printing. Two of these places are indicated by arrows. Electrical current is flowing evenly through the whole surface of PV panel.

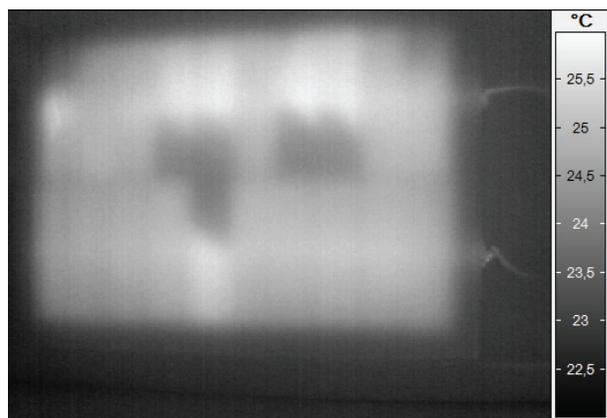
In Fig. 4 there is a PV panel image taken by the IR camera. Resolution of the image is not as good as in the case of EL imaging, but some parts of PV panel without current flow are observable because of lower temperature. On the other hand, damaged parts with current flow are lighter, because they are warmer than the undamaged parts of PV panel and the same current flowing through the smaller surface has a higher density.

Fig. 4. Infrared camera image of a small photovoltaic panel

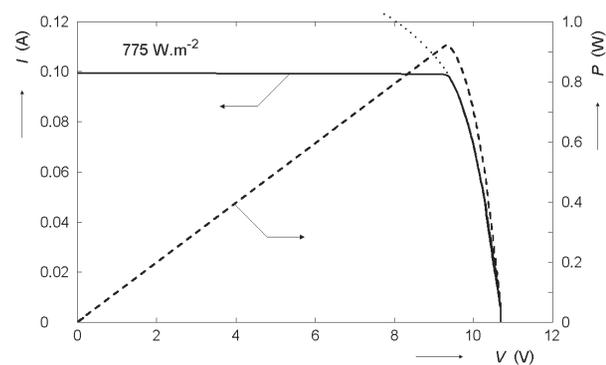
Fig. 5 shows $V-I$ and $V-P$ characteristic of PV panel during the autumn season with solar radiation intensity of 775 W m^{-2} . According to this characteristic, the nominal output power P_{max} should be 1.4 W . As a result of the damage, this PV panel does not reach the above mentioned parameters declared by its producer. The P_{max} and short-circuit current I_{sc} attain about 60% of the declared values (0.84 W and 1.08 A , respectively). In accord with the theory of fundamental physics, the open circuit voltage is not influenced by the damage of PV cells. The corrected ratio is $0.84/1.4 = 0.6$. It means that the power was reduced to 60% of the original value. Fig. 1 shows that there are totally five PV cells with the active area reduced by about 40% connected in series. It is well known that electric current in serial strings of PV cells is limited to the value showed by the cell generating minimum current. So the power reduction of PV panel is in line with 'dark' area of the solar cells disconnected from the initial string of solar cells.

Also, from the shape of $V-I$ characteristic we can see that current shows limitation probably because of the smallest active surface from all PV sections connected

in the series. Characteristic of an undamaged PV panel would probably look like a plot growing to the higher value of the short-circuit current (approximately like the dotted line) (see Carrero et al., 2011; Munoz et al., 2011; Ding et al., 2014).

Fig. 5. $V-I$ and $V-P$ characteristic of a photovoltaic panel during autumn season with solar radiation intensity of 775 W m^{-2}
